TESTING OF THE ACROSS FRAMES OF BUS UPGRADING WITH DIFFERENT QUALITY MATERIALS

Prof. Vasko Stojanovski, PhD, Prof. Vesna Angelevska, PhD
 Faculty of Technical Sciences –University “St. Kliment Ohridski”, Republic of Macedonia

Abstract: In this paper an analysis of the experimental testing of across frames of bus T715 upgrading, manufactured from different quality materials, is given. Obtained results were used for impact assessment of the material quality on carrying capacity of across frames.

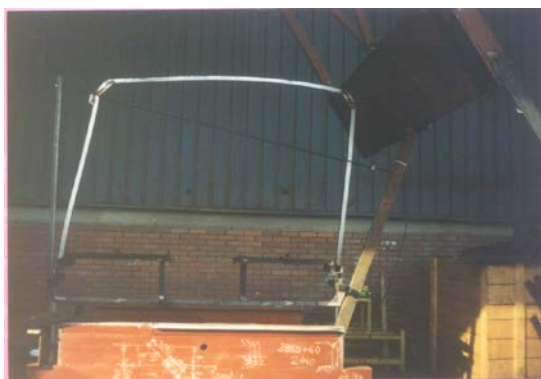
Fig. 2: Transverse frame

The testing methodology is with continuously increase of the force and measurement of the deformations in the points a, b and c.

The first across frame which was tested is made from material S235JHR and with a dimensions that are suitable for the real dimensions of the across frame of the bus. During the tests of the first across frame, successive increases on the force were made, with which a frame was loaded with a 200 [N]. A deformations measurement in the three points a, b and c on the vertical axis of the frame was performed.

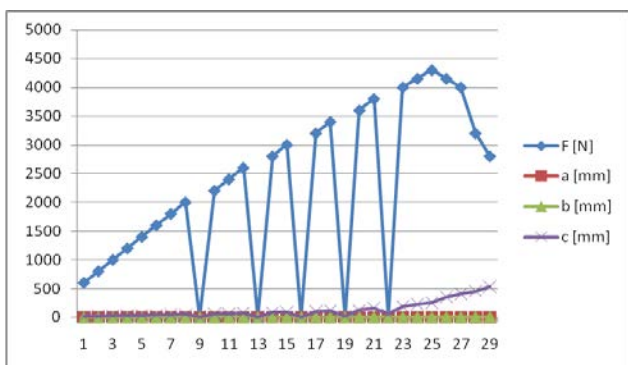
Fig. 5: F-L (b,c) diagram

Diagram display of the obtained results, F-b and F-c diagrams for the two characteristic points are given in the figure 5.

The first noticeable deformations appear in the node “I₁” (measurement point b), during the load of 2800 [N] on the vertical quadrate pipe, 40x40x2 [mm], immediately above enforcements in that node.

During the load of 3200 [N], a noticeable deformations start in the node “d₁” (measurement point b on the contrary side), on the contrary side of the vertical pipes, 40x40x2 [mm].

With further loading over 3300 [N], deformation growth is bigger, because construction is deformed under another functional dependency.

The stretching in the node “I₁” (measurement point b) continued until the load of 4150 [N], under which the first deformations in the node “d₂” (measurement point b) appeared under the load of 4300 [N], under which deformation growth suddenly increases, the force begins to decrease and construction crash happens.
